RE: **KPU Water Division Manager's Report – March 2025**

**MANAGER'S REPORT  
WATER DIVISION  
March 2025**

**Water Main Repairs: Parking Garage under Dock Street by the Museum 3/31/2025**

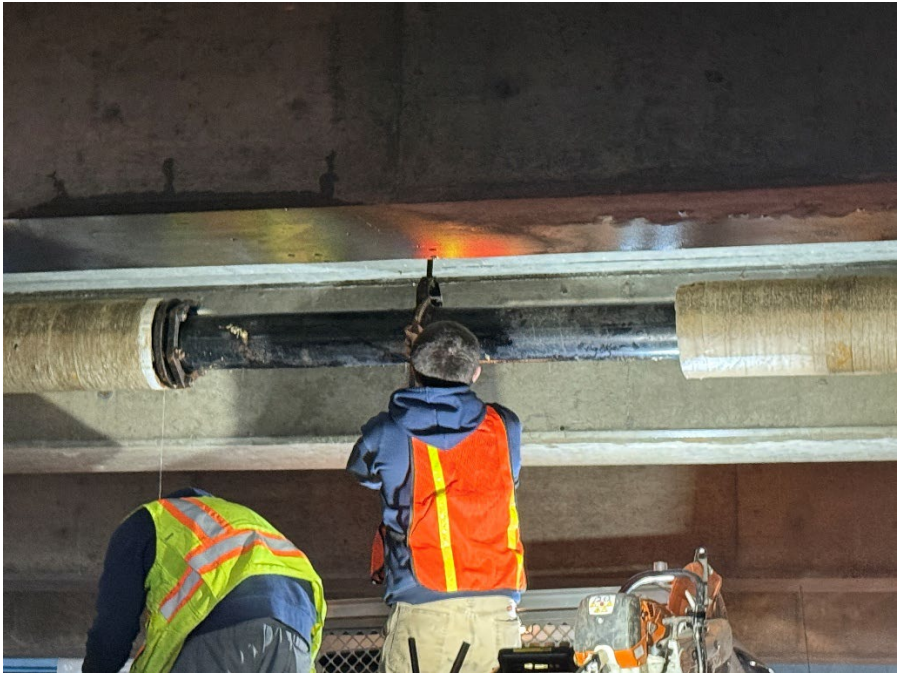
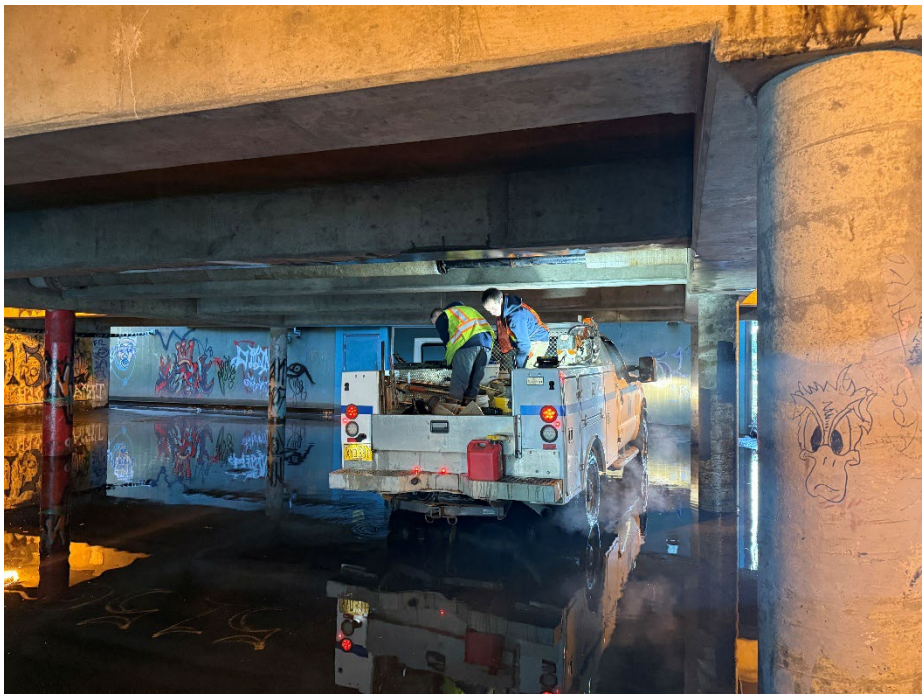
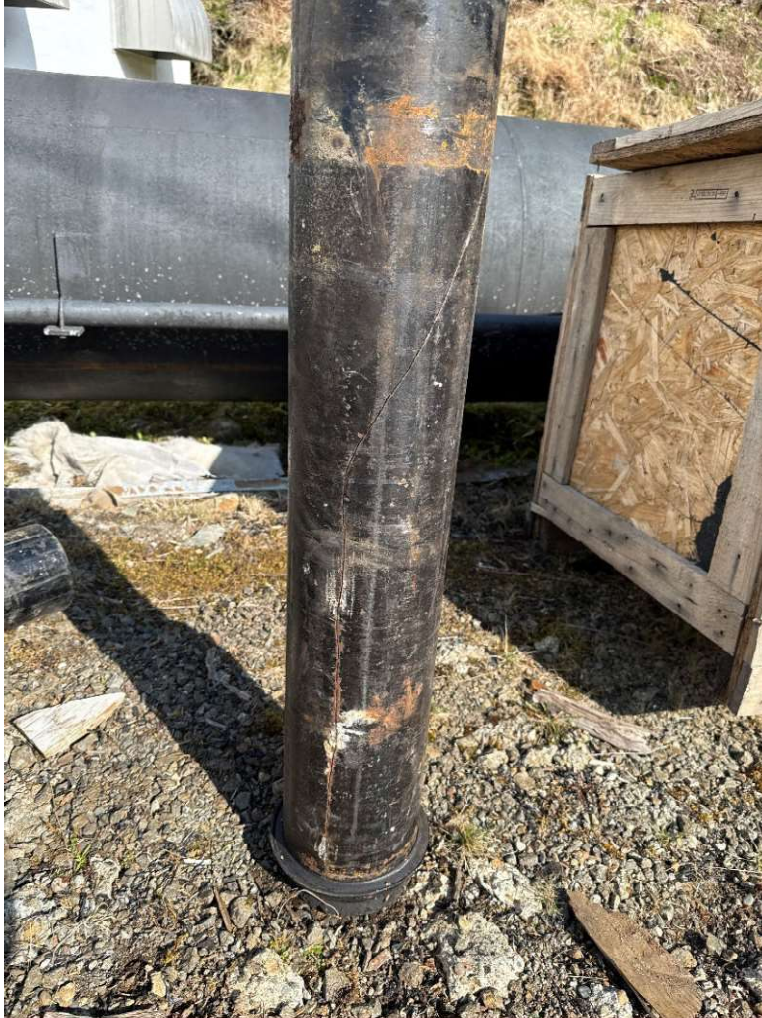
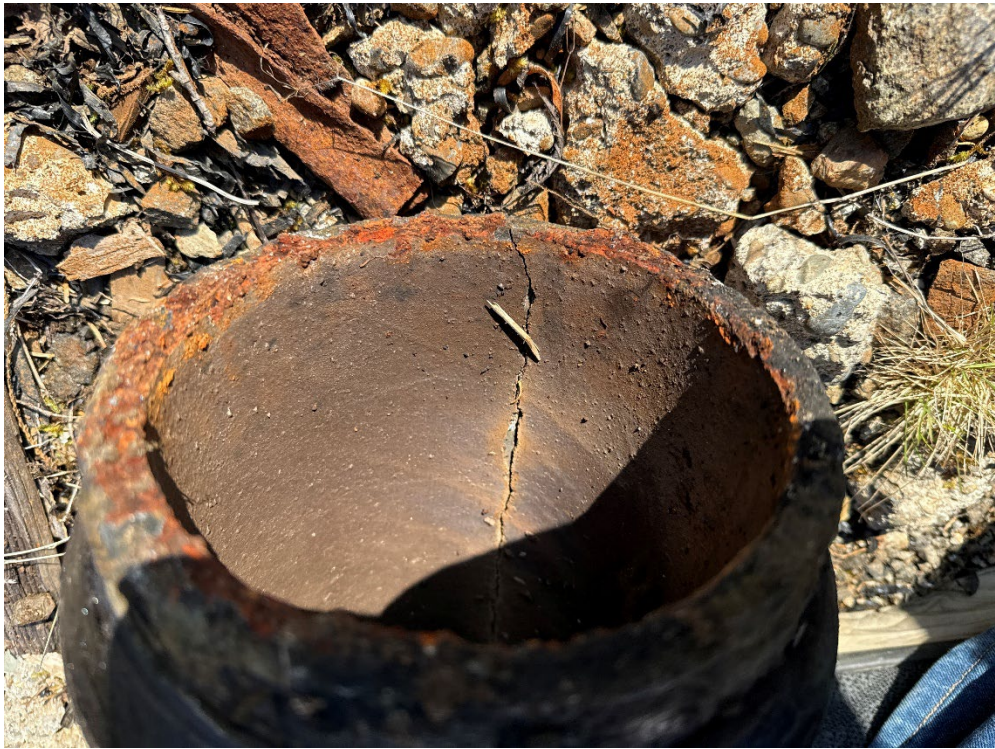
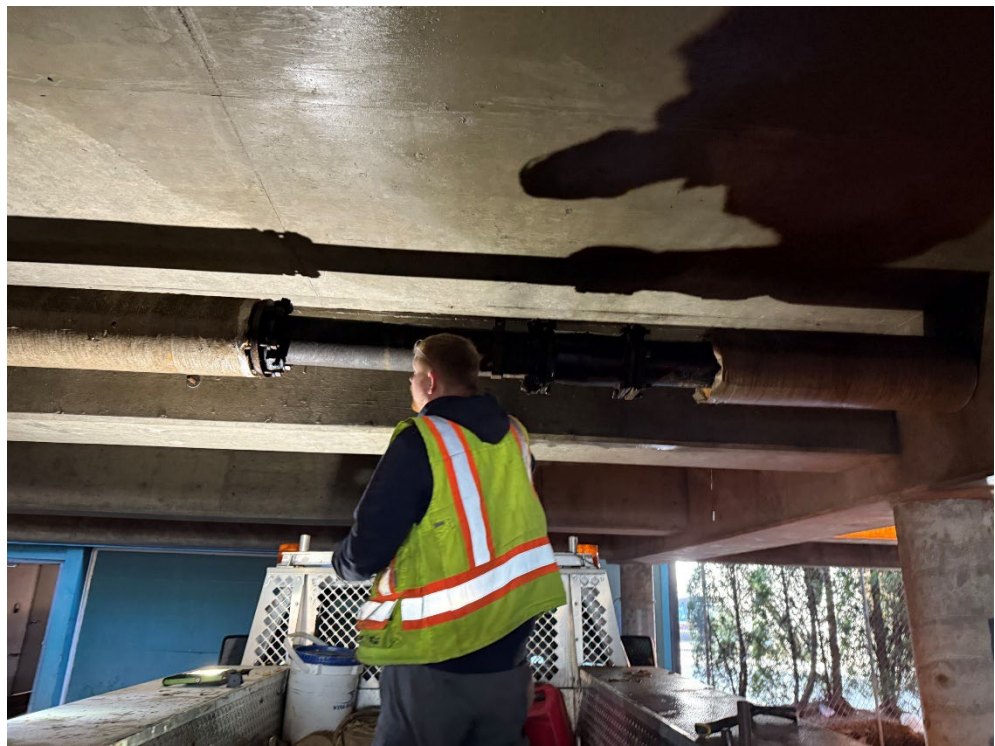
At 6:10 am we received a call from Bailey Power House notifying us that the Police Department called in a water main break under the Dock Street parking garage by the Museum.

Like all cast-iron pipe it is quite fragile and may become subject to failure over time, primarily due to differential settlement or any stress on the pipe. Normally when cast iron pipe breaks it splits around the pipe much like a pencil would break when bent in the middle, but this pipe broke length wise and the crack was about 4 feet long. Because it broke in the parking garage we could work out of the back of our truck to reach the broken water main.

The areas that had no water were between Dock Street and Bawden Street intersection to Dock Street and Mill Street intersection. Plus all of Creek Street was off as well.

We shut off the water main around 8:00 am then we started to cut out 5 foot of the broke cast and replaced it with 5 foot long new 6" ductile iron pipe and added a coupling plus connecting parts. Then we turned the water back on at 10:19 am. We then flushed to remove any air or sediment that might have been in the water lines. We returned back to the shop at 11:00 am and started to head home.
